Public Works Operations  
at U.S. Army Garrison-Yongsan, Korea

May 4, 2010

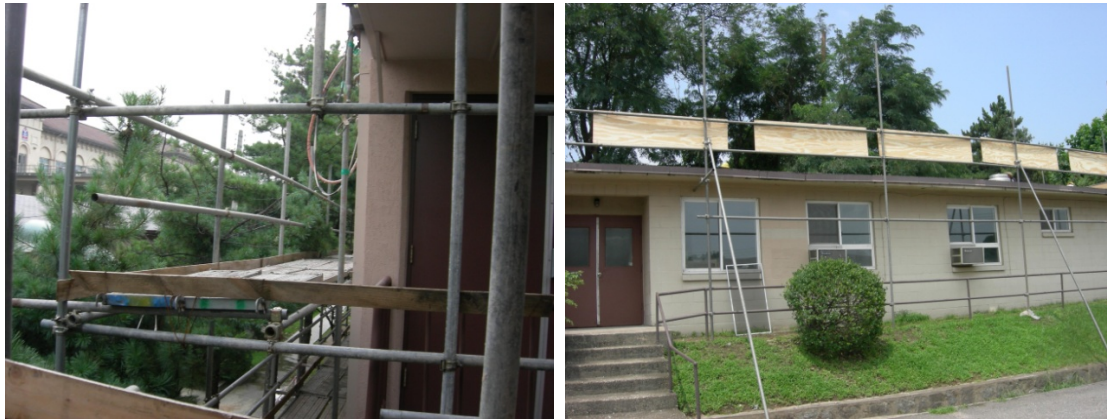
**Figure 1. Scaffolding Around a Building    Figure 2. Fall Protection for Roof Work**

DPW spent \$309,000 (46.5 percent) of the cost of the 27 DOs for “scaffolding” used primarily for fall protection for roofing work. The cost of the scaffolding for this contract was KRW2,050 per square foot, much higher than the IGCE of KRW1,258 per square foot in the existing General Repair Contract. The IDIQ contract for painting had a line item priced at KRW113 per square foot for scaffolding.
